**Coal Burner Condition and
Estimated Remaining Life Evaluation
- IPP Units #1 & 2**

Final Report

**Energy & Environmental Research Corporation
Engineering Services Group
Orrville, Ohio**

Intermountain Power Services Corporation

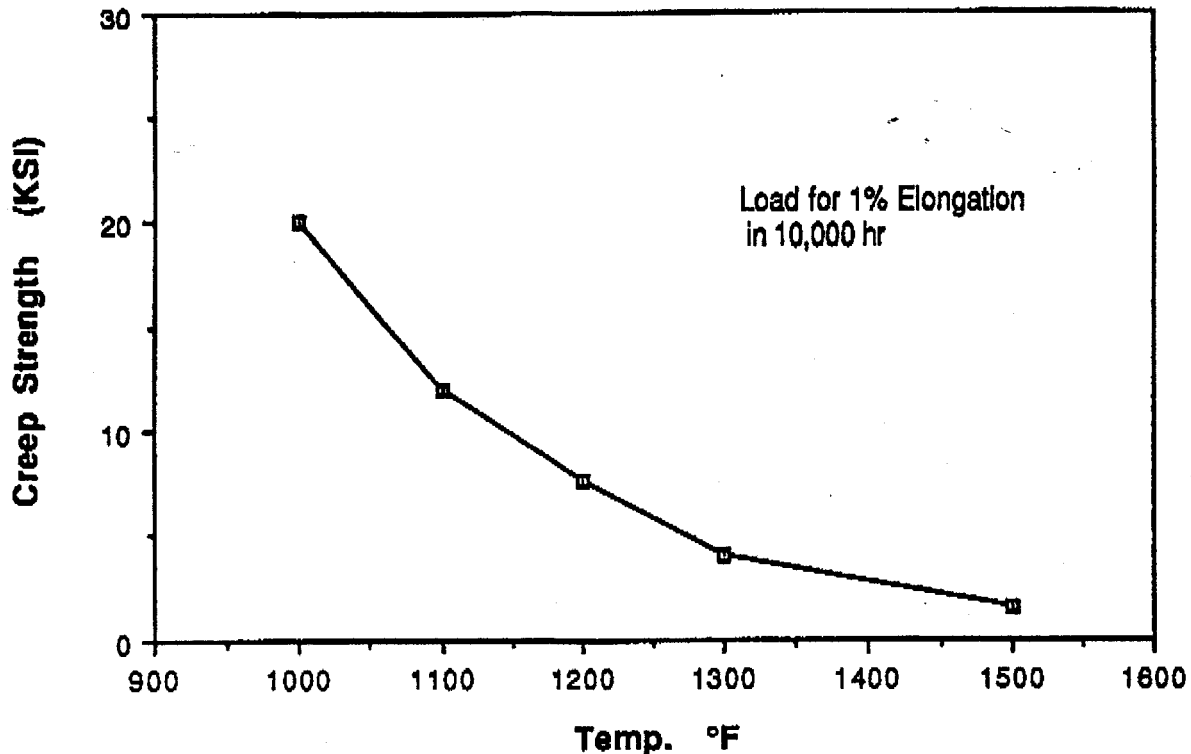
Past burner experience indicates that reducing the maximum temperature to 1150°F on a new burner will result in an expected burner life of twenty to twenty-five years. Although the maximum operating temperature (with regard to oxidation resistance) of the stainless steel material is several hundred degrees higher, the creep strength is greatly reduced at elevated temperatures. Creep strength is the ability to resist permanent strain that increases as a function of time under stress. Depending on the source, the creep strength of AISI 304 stainless steel is approximately 9.5 KSI at 1150°F and 3 KSI at 1350°F. Figure 4 illustrates the creep strength vs. temperature relationship for 304 stainless steels.
